## Implications of Rapid Land Use/Land Cover Changes upon the Environment of the Area Around Nainital in Uttarakhand, India

*Disaster Mitigation and Management Centre, Department of Disaster Management,  
Government of Uttarakhand, Uttarakhand Secretariat, Rajpur Road, Dehradun – 248 001, Uttarakhand, India.*

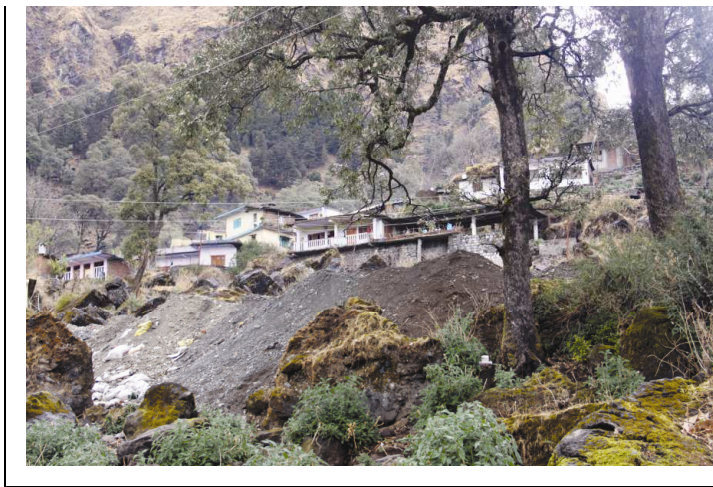
Figure 3 Disposal of excavated debris along the hill slope in Nainital. Obliteration of surface drains by site development works for construction.

It was observed during the field work in the area that steep slopes in many areas are presently being leveled for various construction related initiatives and excavated debris is being disposed off along the hill slopes as also along the surface drains (Figure. 3). At a number of places in the town the drainage network is observed to be encroached, blocked and obliterated (Figure. 4). Anthropogenic activities in the township have not spared even the recharge zones of the lake (Figure. 5) and these are sure to have irreversible adverse impact upon the very existence of the Naini lake.

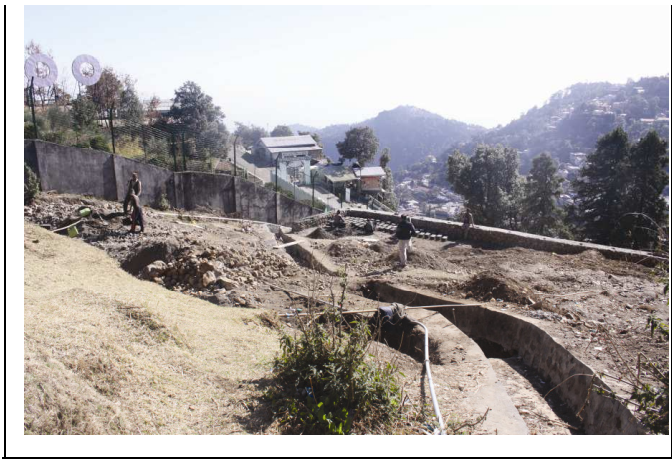
Figure 4   Disposal of excavated debris along the hill slope in Nainital. Obliteration of surface drains by site development works for construction.
