## LANDSLIDE RISK MANAGEMENT IN PRACTICE: PHASED MITIGATION USING THE OBSERVATIONAL METHOD

### 2. Description of the case study

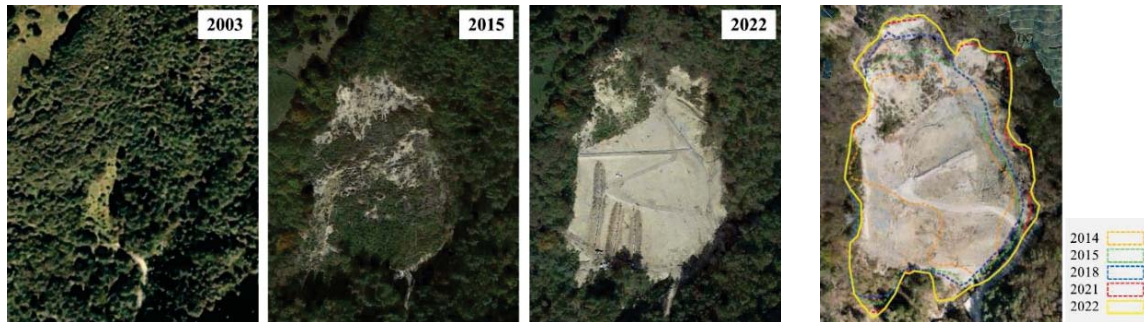
Fig. 1 Evolution of the Paradisi Landslide through the years

The Paradisi landslide takes its name from the village of Paradisi, located in the municipality of *Ponte nelle Alpi*, province of Belluno (Italy). This landslide is classified as a complex movement due to distinct behaviors observed in its head and foot regions. At the head, the movement is predominantly rotational, occurring between the moraine

cover and the alpine flysch, while at the foot, the movement is characterized by spalling lobes, distributed midway down the landslide slope. Among the various triggering factors, heavy winter rainfall played a key role, compounded by the lack of precipitation reabsorption through glaciation due to unusually high temperatures compared to the years before. Additionally, the presence of the Rio San Pietro stream in the center of the affected area fed the landslide, generating high-velocity mudflows that exacerbated instability. The instable volume is between 150,000 and 200,000 m<sup>3</sup>. Before stabilization efforts began, the landslide was moving at a significant rate of several cm/day, leading to the formation of visible fracture lines both upstream and downstream, affecting also the provincial road SP4 “*della Val Cantuna*”, rendering it impassable. The road's closure, combined with the hazard posed by the moving terrain toward the road, necessitated urgent intervention.

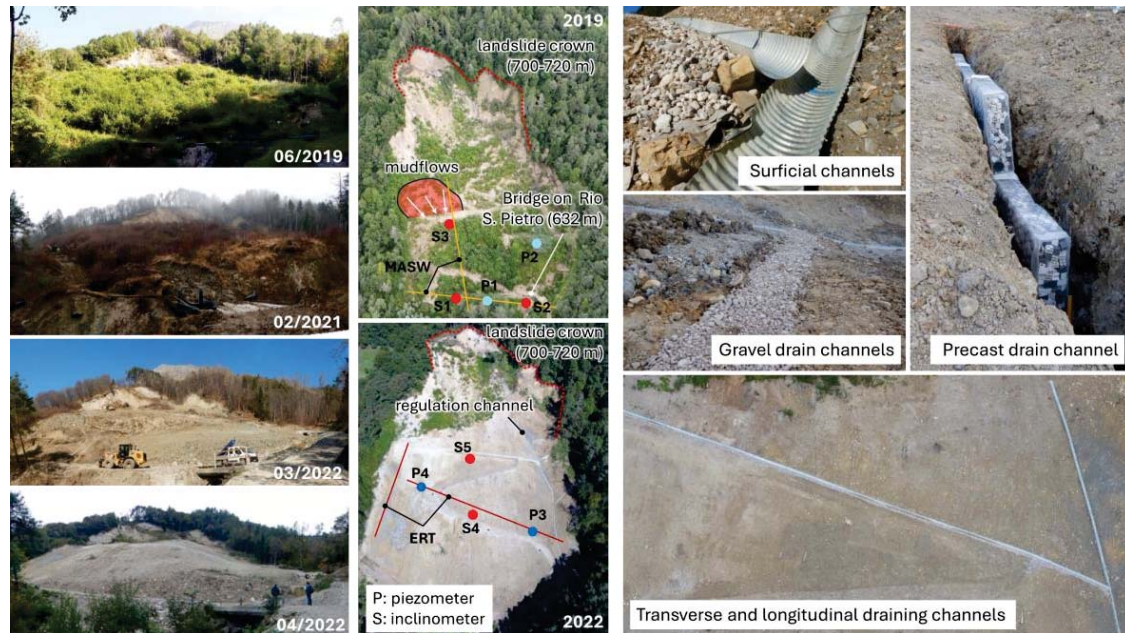
Fig. 2 First phases interventions: reshape and drainage system realization

**1. Site Accessibility Restoration** – The access road, damaged by initial movements, was repaired to facilitate intervention. **2. Slope Reprofilling and Drainage Implementation** – Approximately 23,000 m<sup>3</sup> of material was firstly removed to reshape the slope (Fig. 2). Then, to prevent water runoff, hydraulic bypasses were constructed around the landslide, followed by the reconstruction of the drainage network using prefabricated drainage trenches and channels. The new slope configuration enabled additional monitoring and piezometer installations, strategic tools to determine how to proceed in the next steps. **3. Monitoring-Guided Stabilization** – Continuous data collection refined the intervention strategy, ensuring that additional measures were implemented only when justified. The inclinometer results indicated a significant reduction in slope movements; however, the landslide remained active, necessitating further actions. **4. Smart Passive Anchors** – To enhance slope stability, 42 floating passive anchors were installed in rows, with 3 instrumented using fiber-optic sensors for real-time deformation monitoring. The collected data enabled the precise confirm the efficacy of the location and number of anchors designed. In this context, passive floating anchors (Brezzi et al., 2021) emerged as a cost-effective solution. While these anchors rely on slope movement to activate their stabilizing response and provide lower resistance compared to traditional active anchors, they are simple and quick to install, leading to substantial cost savings. Typically, they are installed in rows with a spacing equal to 3 times their diameter. However, due to budget constraints, the spacing was doubled, resulting in a total of 42 bars 30 m long distributed across 5 rows (Fig 3). Continuous monitoring of movements was particularly crucial in this scenario, as it allowed for the assessment of whether the number of anchors was sufficient to stabilize the slope. The intervention adhered to the observational method, maintaining flexibility for additional reinforcements with traditional spacing, should they become necessary.

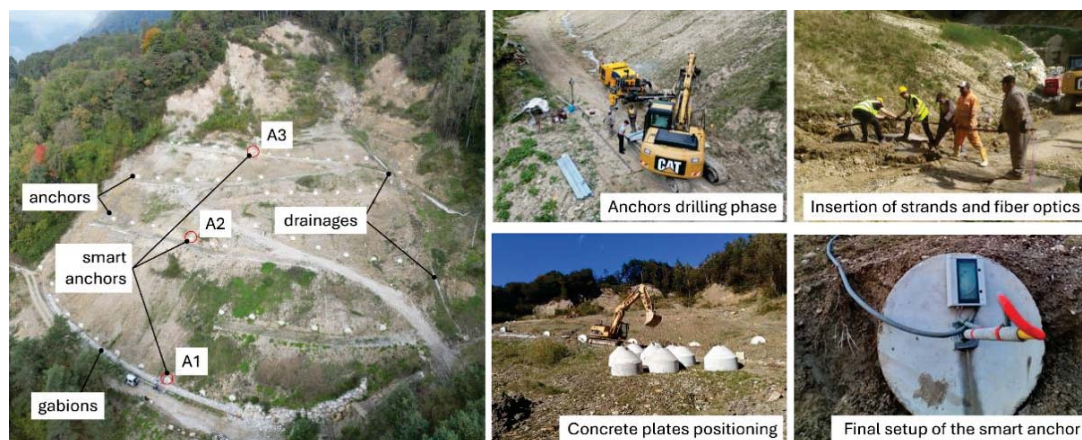
Fig. 3 Site overview with installed anchors, drilling and anchors installation, followed by fiber optic placement and setup

As stated, to enhance the monitoring system, 3 of the anchors were instrumented with optical fibers (Cola et al., 2019; Brezzi et al., 2023), enabling real-time deformation monitoring along their entire depth. This approach provided valuable insights into the effectiveness of the stabilization system. Notably, the instrumented anchors

were strategically placed across 3 different rows, facilitating a detailed analysis of the ongoing kinematics and ensuring accurate control of the slope's stability. **5. Final Adjustments and Long-Term Monitoring** – Ongoing observations determine whether further reinforcements are required, preventing unnecessary expenditures on premature stabilization efforts. When the slope is deemed sufficiently stable, restoration of the damaged areas and the redevelopment of the road infrastructure can proceed. Planned activities also include the reconstruction and reinforcement of the containment of the Rio San Pietro, a crucial intervention to prevent the entry of additional volumes of water into the landslide body, thus contributing to ensuring the long-term stability of the slope. Continuous monitoring of both the landslide and the anchors will allow for the assessment of whether additional safety measures for the slope are needed, such as implementing further floating anchors, new drainage systems, or other measures, only where necessary. This approach enables the economic investment for slope stabilization to be spread over time and optimizes available resources by adapting the intervention plan to the actual site conditions as they evolve with the measures already implemented.
